**Environmental
Monitoring Services
at the Former Mining
Areas of Silvermines
(Co. Tipperary) and Avoca
(Co. Wicklow)**

**Avoca Monitoring Report
- Round 1 (2016)**

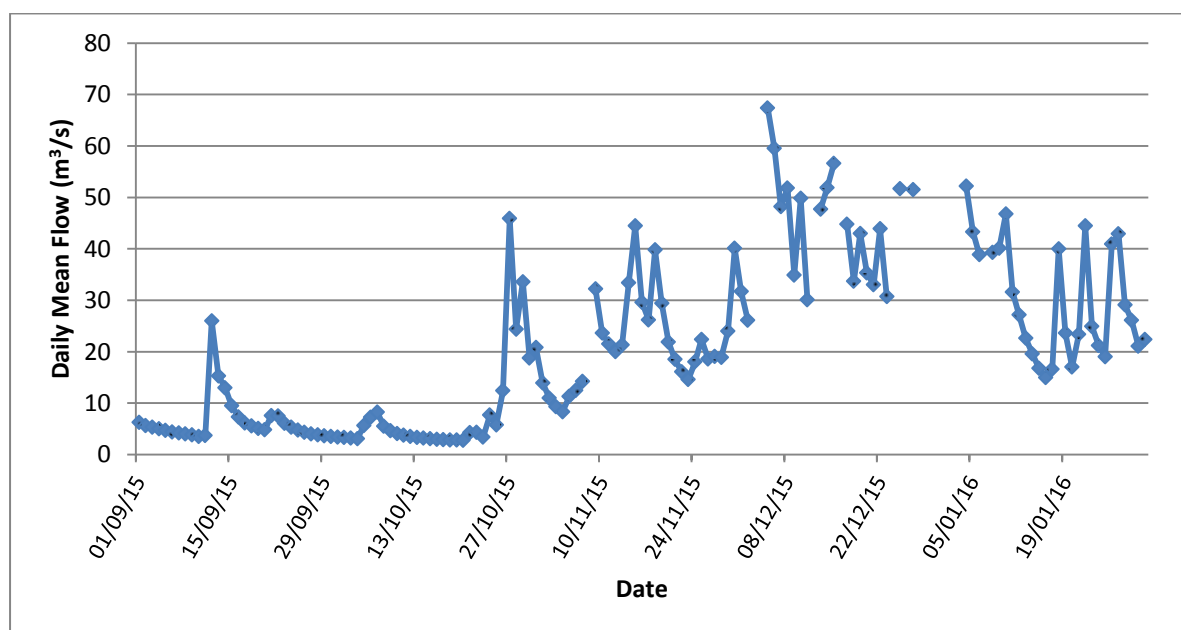
Figure 2 Mean Daily Flow (m^3/s) at Whites Bridge (Station 10044) from 1 Sept 2015 to 27 Feb 2016

The flow record from 1 September 2015 to 27 February 2016 of Whites Bridge GS is reproduced in Figure 2 and for Wicklow County Council Maintenance Yard GS from 1 September 2015 to 10 February 2016 in Figure 3. Data are limited for Wicklow Co. Co. Maintenance Yard GS for the period November to January due to battery issues. The figures show the measured flows ranged from $>50 \text{ m}^3/\text{s}$ to approximately $3\text{--}4 \text{ m}^3/\text{s}$ during low-flow. The flashy nature of the river shows a rapid response to rainfall. The median flow for this period of approximately $19.1 \text{ m}^3/\text{s}$ at Whites Bridge GS is higher than the long term median of approximately $8.3 \text{ m}^3/\text{s}$ (CDM Smith, 2015), which reflects the relatively high levels of rainfall during the period November to February. Flow in December was particularly high with the daily mean flow recorded at $67.4 \text{ m}^3/\text{s}$ on 5 December 2015.

The river appears to respond similarly at both gauging stations as can be observed from the peaks in both figures. A discussion of the differences in flow rates between the two gauges is provided in Section 6.5.

As described in Section 5.1 Surface Water Flows, there are two EPA stream flow gauges on the Avoca River near the mine site: Whites Bridge GS (EPA station 10044) and the Wicklow County Council Maintenance Yard GS (EPA Station 10045). The measured water elevations from 12 August 2015 to 15 February 2016 for Whites Bridge GS and Wicklow County Council Maintenance Yard GS are reproduced in Figure 10. Data are missing for GS 10045 for several periods of time due to battery issues; the logger has since been replaced. The figure demonstrates that the river appears to respond similarly at both gauging stations.

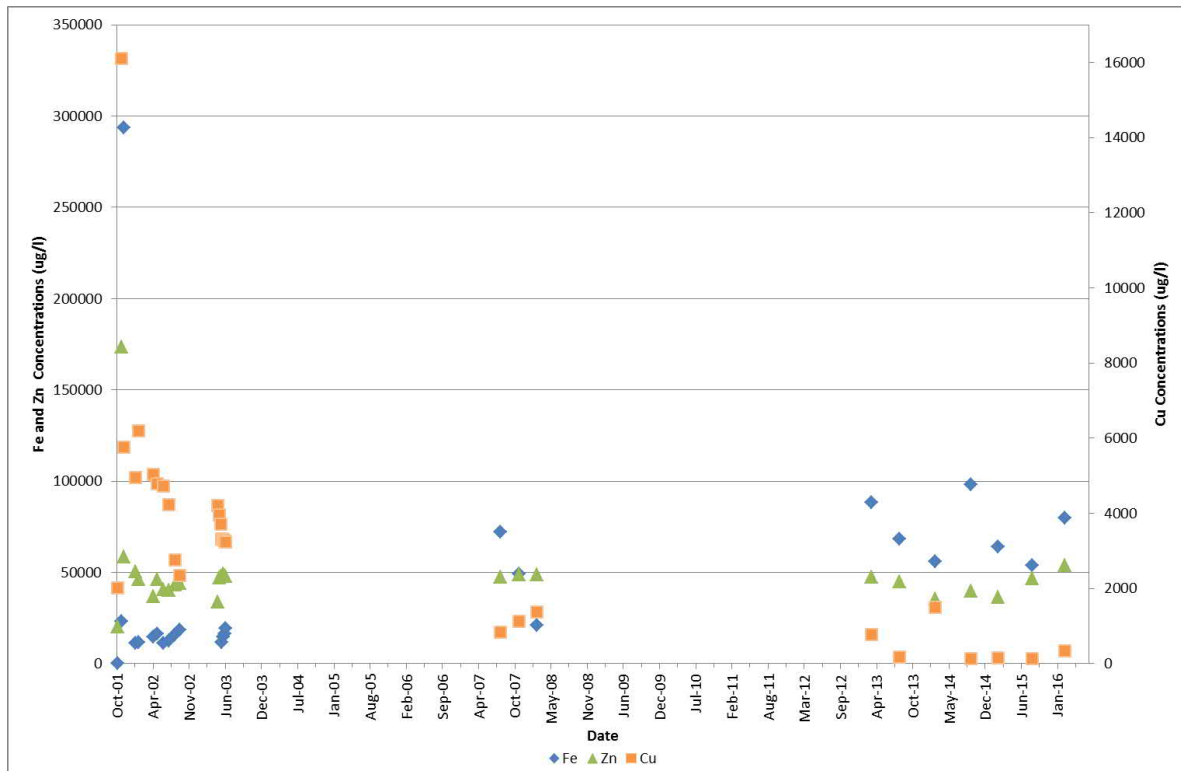
Figure 5 Concentration trends for dissolved copper, zinc and iron within the Deep Adit Discharge (Oct 2001 to Feb 2016)

This section discusses concentration time trends for select locations including the Deep Adit, the Road Adit and one location on the Avoca River (Avoca Bridge) for selected parameters including dissolved copper, zinc and iron. The trends are shown graphically in Figure 5 (Deep Adit from Oct 2001 to Feb 2016), Figure 6 (Road Adit from Oct 2001 to Feb 2016) and Figure 7 (Avoca River at Avoca Bridge from Oct 2001 to Feb 2016).

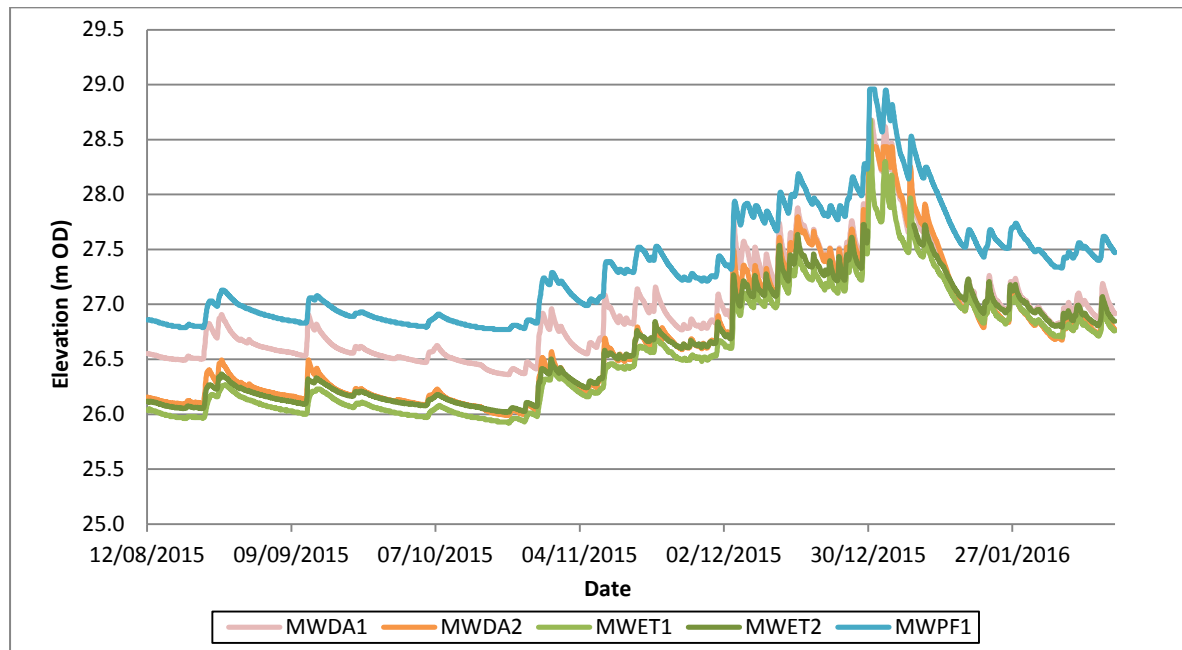
Figure 8 Groundwater Elevations in the Avoca Mining Area from 12 Aug 2015 to 15 Feb 2016

Automatic pressure transducers and loggers have been installed in the six wells owned by the Department. Figure 8 shows the groundwater elevations of the 5 wells located in the Avoca Mining Area from 12 August 2015 to 15 February 2016. Figure 9 shows the groundwater elevation at MWSA2 at Shelton Abbey Tailings Facility from 12 August 2015 to 15 February 2016. Data are omitted for MWET2 for the period 30 December 2015 to 7 January 2016 due to irregular readings. Irregular readings are highlighted in Appendix C (Table C-1) of the corresponding Data Report.

Figure 8 shows that the heads are higher in the shallow alluvium monitoring well MWDA1 with respect to its nested well pair in the deeper alluvium MWDA2 which suggests an apparent downward hydraulic gradient between the pair, which infers that groundwater in the spoils discharges into the alluvial aquifer.

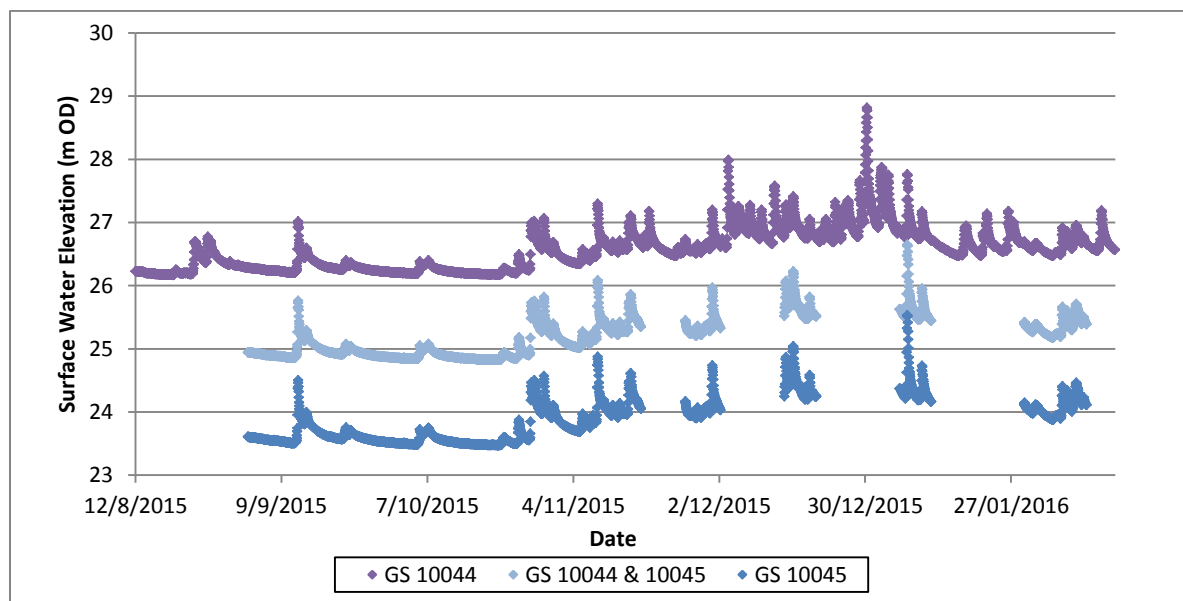
Figure 10 Elevation of the Avoca River at GS 10044 and GS 10045 at the Deep Adit Area from 12 Aug 2015 to 15 Feb 2016

The distance between the two gauging stations is approximately 470 metres. The measured surface water elevations were used to calculate the average gradient between the two gauges which was 0.006 for the monitoring period. Streambed characteristics and the elevations both influence the flow rates and help define any apparent losses or gains in river flow.

- MWET1, MWET2, GW1/05 and GW2/05 are located approximately equidistance between the two gauges. To take account of the gradient between the two gauges, the river water elevation can be estimated using both the Whites Bridge GS (GS 10044) and the Wicklow County Council Maintenance Yard GS (GS 10045) by selecting a midpoint water level. Note that water level data was unavailable for GS 10045 for several periods including 16 February and 28 February due to battery failure and therefore the river water elevation could not be estimated for these time periods. Using the available data, the estimated surface water elevations for the emergency tailing area for the period 12 August 2015 to 15 February 2016 are displayed on Figure 10 (GS 10044 & GS 10045);

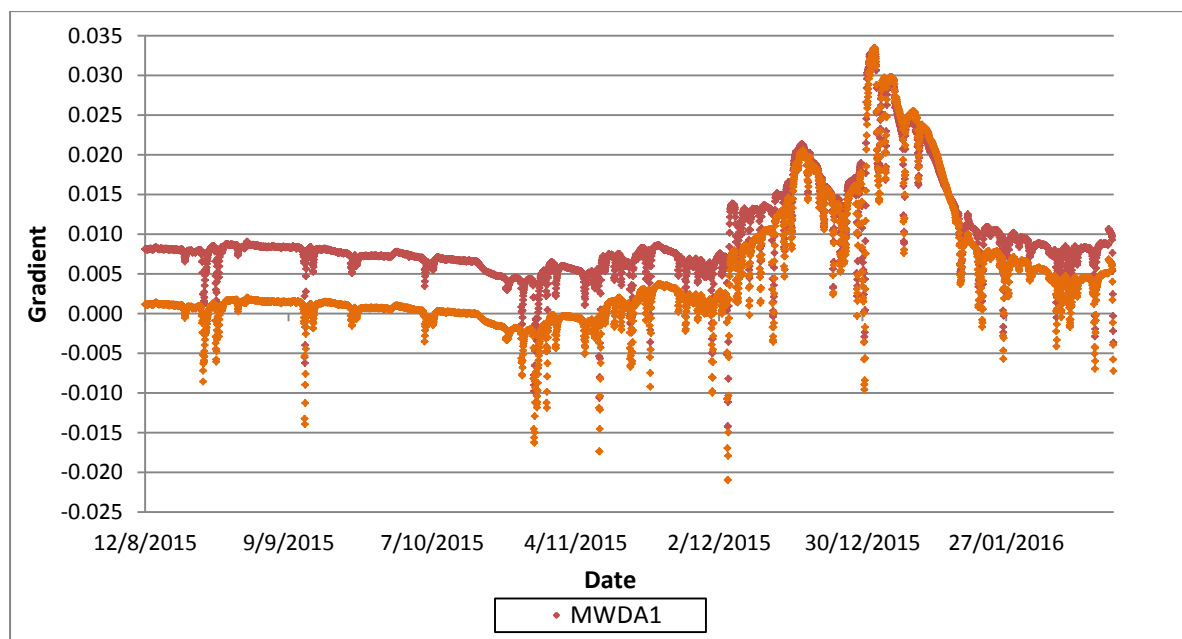
Figure 12 Calculated Groundwater Gradient to the Avoca River at the Deep Adit Area from 12 Aug 2015 to 16 Feb 2016

However, Figure 12 shows that a negative gradient occurs in the Deep Adit area during periods of high flow, particularly when there was a rapid rise in water level. Between 28 and 30 December a significant hydrological (rainfall) event resulted in groundwater levels rising in MWDA1 and MWDA2 by approximately 1.2 metres. A negative gradient can be observed during this period between the river and MWDA2, as shown in Figure 12. During the 28 to 30 December event the river water level also rose (approximately 1.2 metres) but more rapidly which resulted in water moving into the monitoring well area, apparent from the rise in groundwater levels. It is likely the river water moved into an unsaturated zone, which could result in mobilising new metals if they were not exposed before. Also, this zone of fluctuation may under repeated oxidizing reducing conditions result in the precipitation and mobilization of metals.

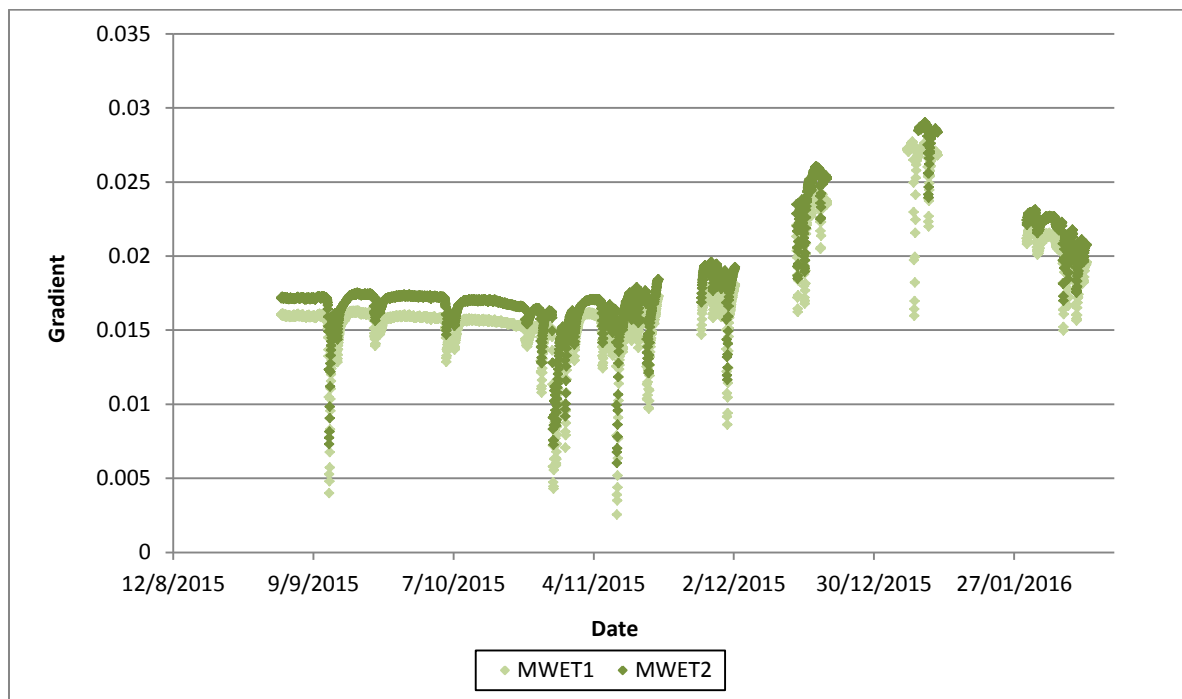
Figure 14 Calculated Groundwater Gradient to the Avoca River at the Emergency Tailings Area from 12 August 2015 to 16 February 2016

For MWET1 and MWET2 only positive gradients were observed during the monitoring period with a minimum gradient of 0.003 (MWET1) and a maximum of 0.029 (MWET2). Note that the elevations are based on the GPS survey of the boreholes and the river water elevations were

estimated using both the Whites Bridge GS elevation and the Wicklow County Council Maintenance Yard gauges because they are located equidistance between the gauges.
