**Environmental  
Monitoring Services  
at the Former Mining  
Areas of Silvermines  
(Co. Tipperary) and Avoca  
(Co. Wicklow)**

**Avoca Monitoring Report  
- Round 2 (2013)**

<b>Client</b>		Department of Communications, Energy and Natural Resources		
<b>Project</b>		Environmental Monitoring of Former Mining Areas of Silvermines and Avoca		
<b>Project No:</b>		95735		
<b>Report</b>		Monitoring Report for the Former Mining Area of Avoca – Round 2		
<b>Document Reference:</b>		95735/40/DG/10		
<b>Version</b>	<b>Author</b>	<b>Checked</b>	<b>Reviewed</b>	<b>Date</b>
Draft 1	L Gaston R L Olsen	R O'Carroll	R L Olsen	November 2013
Final 1	L Gaston R L Olsen	R O'Carroll	R L Olsen	February 2014

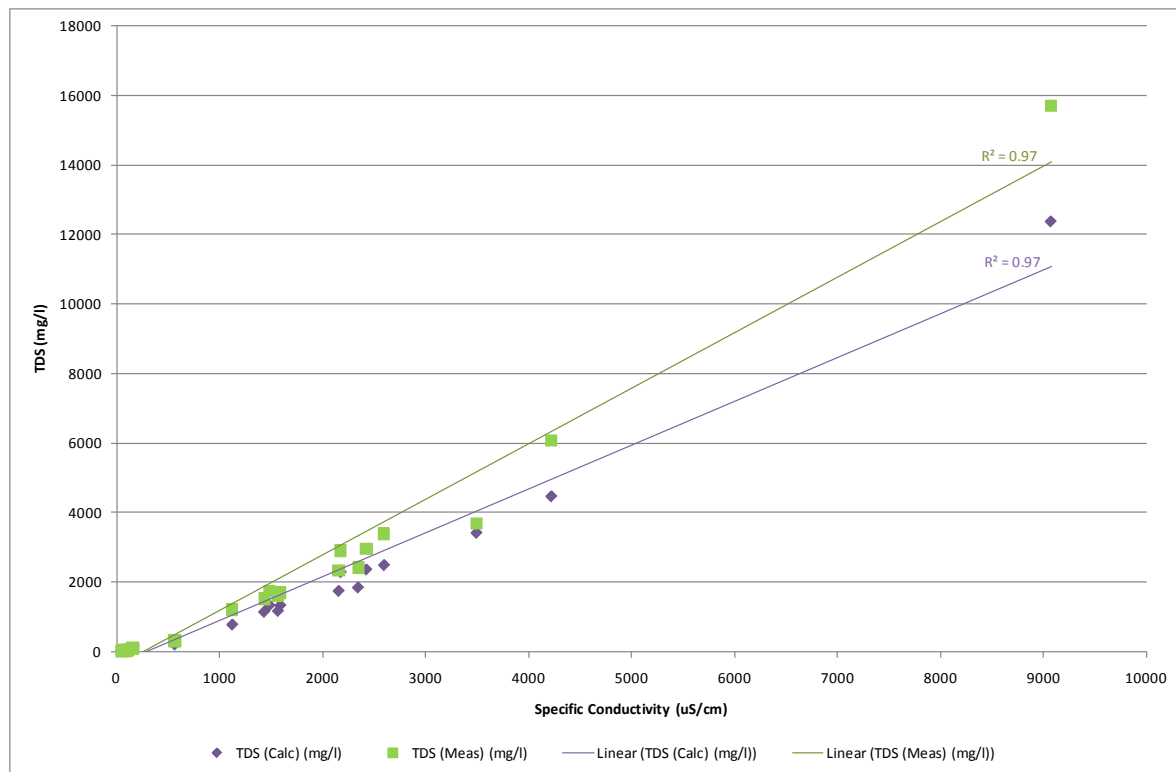
**Figure 1 Relationship of Specific Conductivity and Total Dissolved Solids (TDS)**

Sample Description	Sample Type	Conductivity @ 20 deg.C	TDS (Calc)	TDS (Meas)	Ratio	
		(uS/cm)	(mg/l)	(mg/l)	SC/ TDS- Calc	SC/ TDS - Meas
MWDA1	GW	2154	1747	2340	1.2	0.9
MWDA2	GW	1588	1331	1700	1.2	0.9
MWPF1	GW	153	82	84	1.9	1.8
SG104	GW	9071	12387	15700	0.7	0.6
GW1/05	GW	2423	2363	2970	1.0	0.8
GW2/05	GW	1430	1145	1530	1.2	0.9
MWET1	GW	2595	2492	3400	1.0	0.8
MWET2	GW	3493	3419	3700	1.0	0.9
MWSA2	GW	2174	2287	2910	1.0	0.7
Ballygahan Adit	Adit	2342	1846	2430	1.3	1.0
Cronebane Inter. Adit	Adit	1121	778	1220	1.4	0.9
Cronebane Pit Lake	Pit Lake	563	204	316	2.8	1.8
Cronebane Shallow Adit	Adit	4220	4472	6090	0.9	0.7
Deep Adit	Adit	1483	1327	1750	1.1	0.8
Road Adit	Adit	1565	1172	1630	1.3	1.0
Vale View	SW	140	74	96.3	1.9	1.5
Ballinacleish Bridge	SW	43	21	31	2.0	1.4
DS Deep Adit	SW	67	36	45.6	1.9	1.5
Lions Bridge	SW	78	40	44.4	2.0	1.8
Site T1	SW	56	27	43	2.1	1.3
Whites Bridge	SW	70	35	48.8	2.0	1.4
Whites Bridge GS	SW	66	34	35.6	2.0	1.9

Wicklow CO.CO. Main. Yard GS	SW	79	42	57.8	1.9	1.4
Avoca Bridge	SW	89	48	51.1	1.9	1.7
Site T5	SW	99	50	40	2.0	2.5
Sulphur Brook	SW	153	96	122	1.6	1.3
US Shelton Abbey	SW	102	61	65.6	1.7	1.6
DS Shelton Abbey	SW	107	64	71.1	1.7	1.5

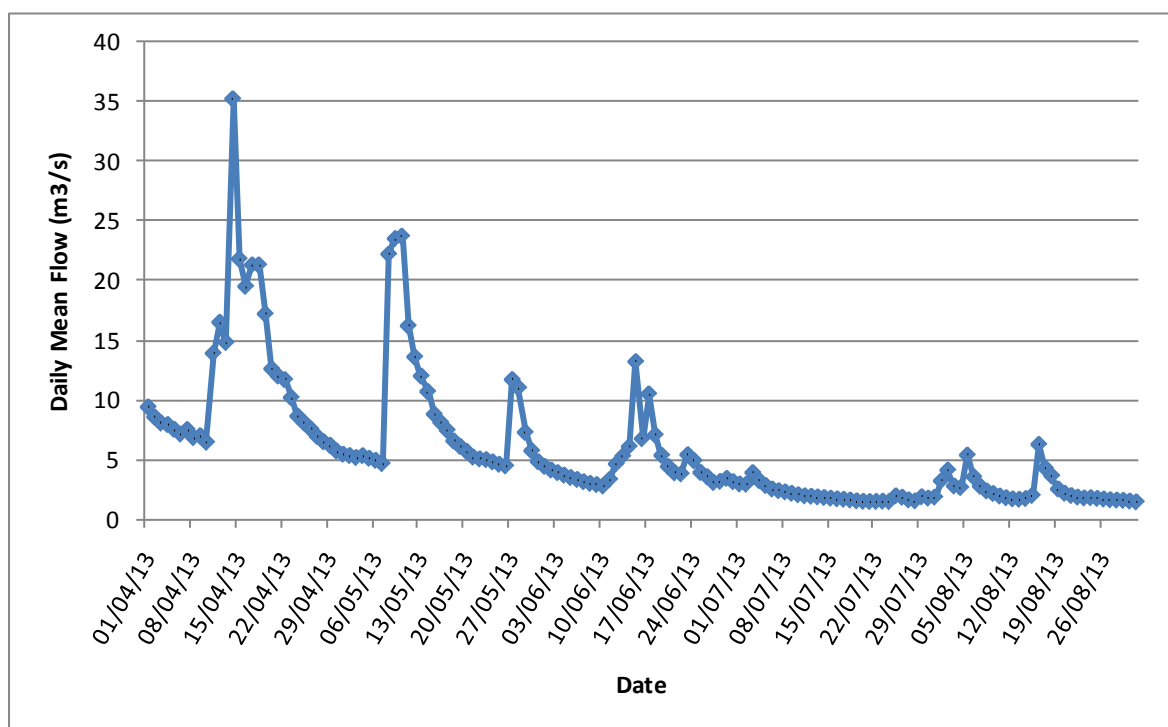
Figure 2 Mean Daily Flow ( $\text{m}^3/\text{s}$ ) at Whites Bridge (Station 10044) from 1 Apr to 31 Aug 2013

The flow record from 1 April to 31 August 2013 of Whites Bridge GS is reproduced in Figure 2 and for Wicklow County Council Maintenance Yard GS in Figure 3. The figures show the measured flows ranging from  $>20 \text{ m}^3/\text{s}$  following major rainfall events to approximately  $1\text{--}2 \text{ m}^3/\text{s}$  during low-flow. The flashy nature of the river shows a rapid response to rainfall. The median flow for this period was approximately  $4 \text{ m}^3/\text{s}$ , which is relatively low for the Avoca River with this figure being less than half the norm of the long term median of approximately  $10 \text{ m}^3/\text{s}$  (CDM Smith, 2013). Flow in July and August were particularly low with the daily mean flow rarely exceeding  $5 \text{ m}^3/\text{s}$ .

The river appears to respond similarly to rainfall at both gauging stations as can be seen in both figures. The peaks in flow during rainfall events are slightly higher at Whites Bridge GS which is the upstream location by 1 to  $2 \text{ m}^3/\text{s}$ . The recessions in the graph after each rainfall event are shown to be very similar also in the figures.

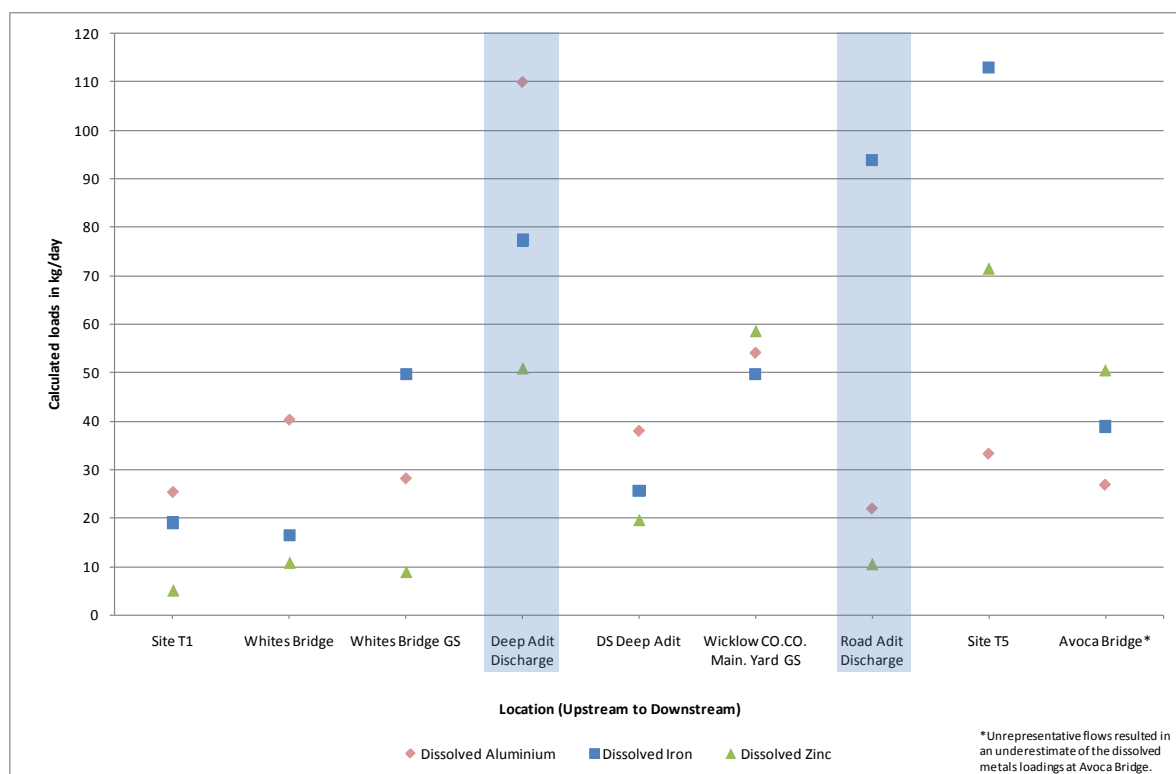
**Figure 4 Calculated Loads of Dissolved Aluminium, Iron and Zinc in kg/day in Avoca River and the Deep and Road Adits in August 2013**

The apparent difference in dissolved metal loads along this stretch of the Avoca River between Whites Bridge and the DS Deep Adit is clearly shown on Figure 4 and is probably due to the complex nature of the infiltration from the Deep Adit discharge ditch and the input of contaminated groundwater through this area, from the Deep Adit spoils.

The Deep Adit and the Road Adit had similar loads of sulphate (1130 and 1100 kg/day), copper (0.21 and 0.45 kg/day) and iron (77.4 and 93.9 kg/day). However, the Deep Adit has much higher loadings of aluminium and zinc with loads of 110 and 50.9 kg/day at the Deep Adit and 22.1 and 10.5 kg/day at the Road Adit. These calculated loads may be an over estimation of the loads

- There were significant differences in the calculated loads of dissolved metals for the Deep Adit and the Road Adit to what was actually calculated for the Avoca River at the locations downstream of the respective discharges. This is due to the precipitation of metals resulting in attenuation occurring within the ditches before discharging or infiltrating into the Avoca River, as discussed in Section 5. In order to understand the direct loads that are actually discharging to the Avoca River from both adits, consideration should be given to collecting extra representative samples from both adits just before they discharge to the river. This will also allow for an estimate of the contaminant loads discharging to the Avoca River as diffuse flow between Whites Bridge and the Deep Adit confluence to be estimated; and

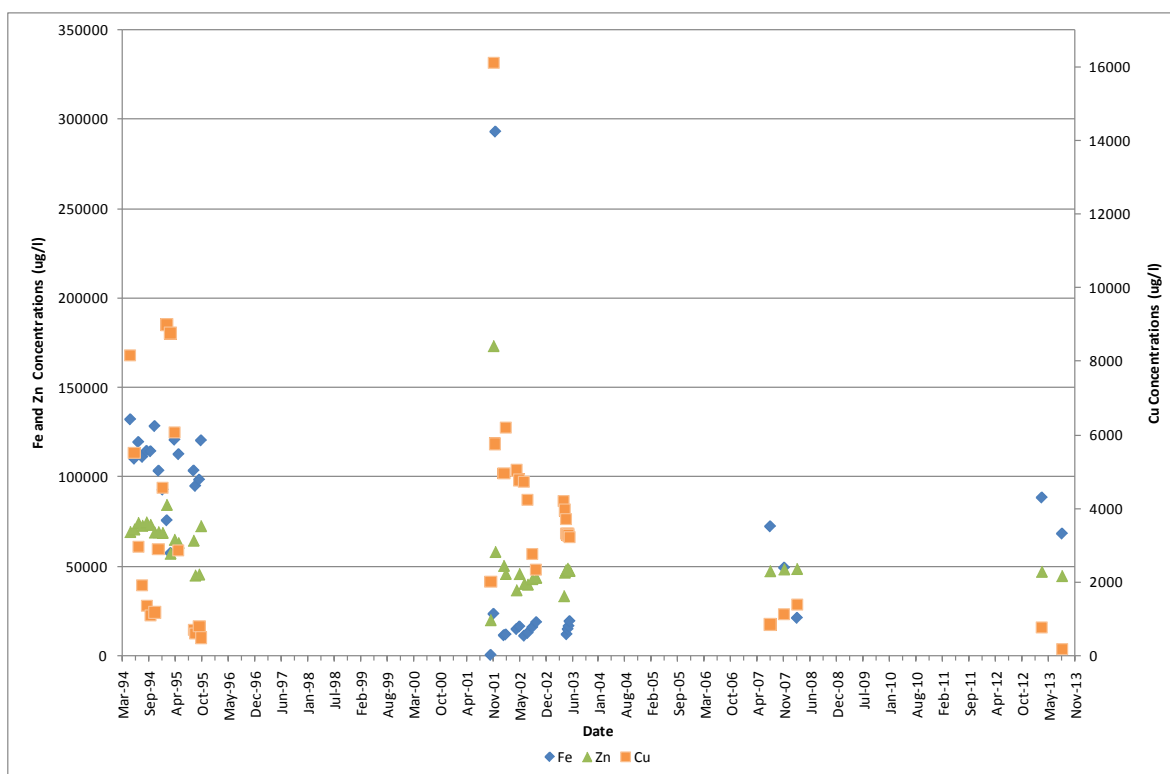
**Figure 5 Concentration trends for dissolved copper, zinc and iron within the Deep Adit Discharge (Dec 1993 to Aug 2013)**

A general declining trend in metal concentrations for both the Deep and Road adits can be inferred from Figure 5 and 6; however, a seasonal trend exists with some peaks in concentration that can mask this overall trend.

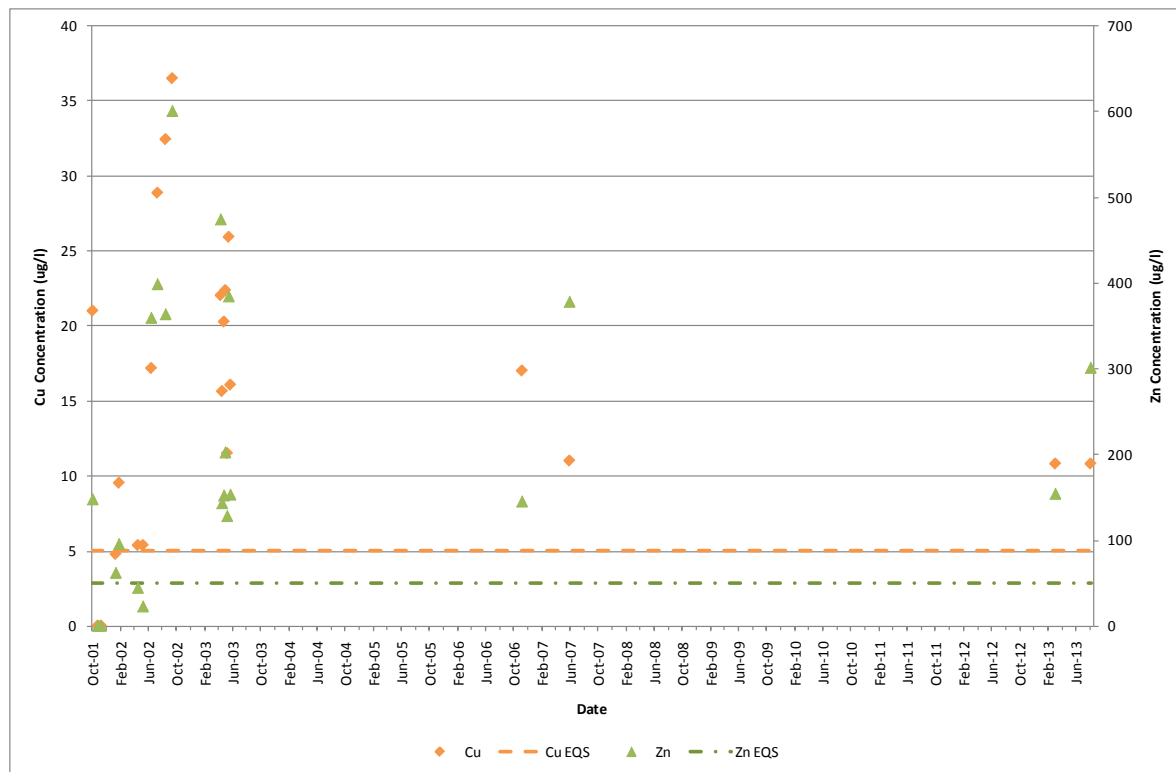
**Figure 7 Concentration trends for dissolved copper and zinc at Avoca Bridge compared with the environmental quality objective (EQS) (May 2001 to Aug 2013)**

Figure 7 displays the results for dissolved copper and zinc in the Avoca River at Avoca Bridge which is downstream of the main Avoca Mining Area, from 2001 to present. The ecological assessment criteria (or EQS) are also shown on the graph for reference. The results also appear to be trending downwards but further analysis on seasonal trends will be required as more data becomes available.

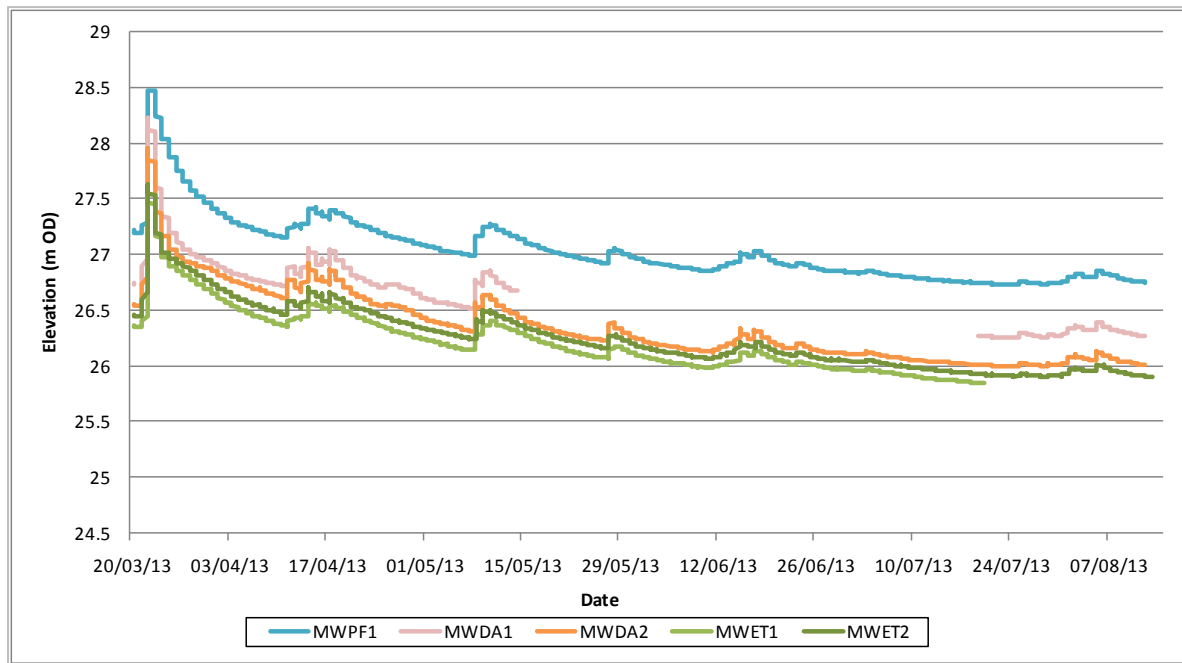
**Figure 8 Groundwater Elevations in the Avoca Mining Area from 20 March to 13 August 2013**

Automatic pressure transducers and loggers have been installed in the six wells owned by the Department. Figure 8 shows the groundwater elevations from the 5 wells located in the Avoca Mining Area from 20 March 13 August to 2013. Data are missing for MWDA2 from 14 May to 19 July due to a fault with the batteries, which were replaced on 19 July. Figure 9 shows the groundwater elevation at MWSA2 at Shelton Abbey Tailings Facility between 20 March and 14 August 2013.

Figure 8 shows that the heads are higher in the shallow alluvium monitoring well MWDA1 with respect to its nested well pair in the deeper alluvium MWDA2 which suggests an apparent downward hydraulic gradient between the pair, which infers that groundwater in the spoils discharges into the alluvial aquifer.

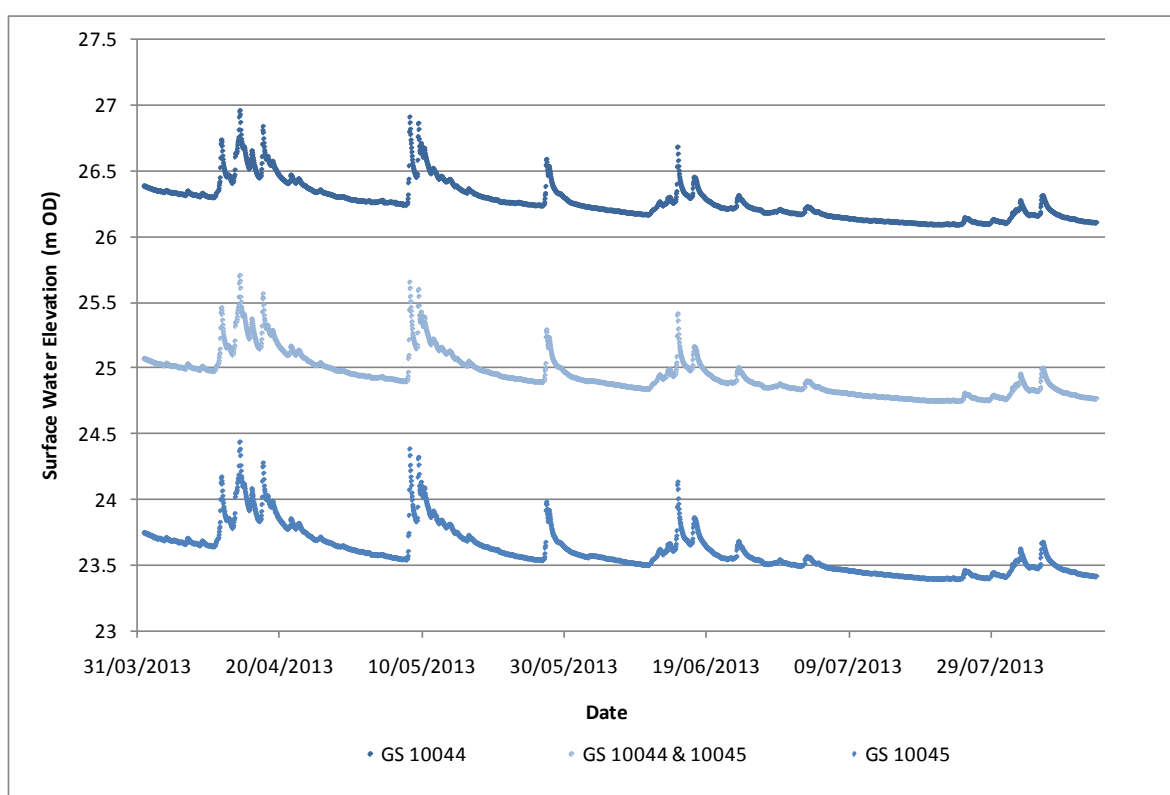
**Figure 10 Elevation of the Avoca River at GS 10044 and GS 10045 at the Deep Adit Area from 1 April to 12 August 2013**

As described in Section 5.1 Surface Water Flows, there are two EPA stream flow gauges on the Avoca River near the mine site: Whites Bridge GS (EPA station 10044) and the Wicklow County Council Maintenance Yard GS (EPA Station 10045). The measured water elevations from 1 April to 31 August 2013 of Whites Bridge GS and Wicklow County Council Maintenance Yard GS are reproduced in Figure 10. The figure demonstrates that the river appears to respond similarly to rainfall at both gauging stations.

The distance between the two gauging stations is approximately 470 metres. The measured surface water elevations were used to calculate the average gradient between the two gauges which was 0.006 for the monitoring period. Combined with streambed characteristics and the elevations, they both influence the velocities and help define any apparent losses or gains in river flow.

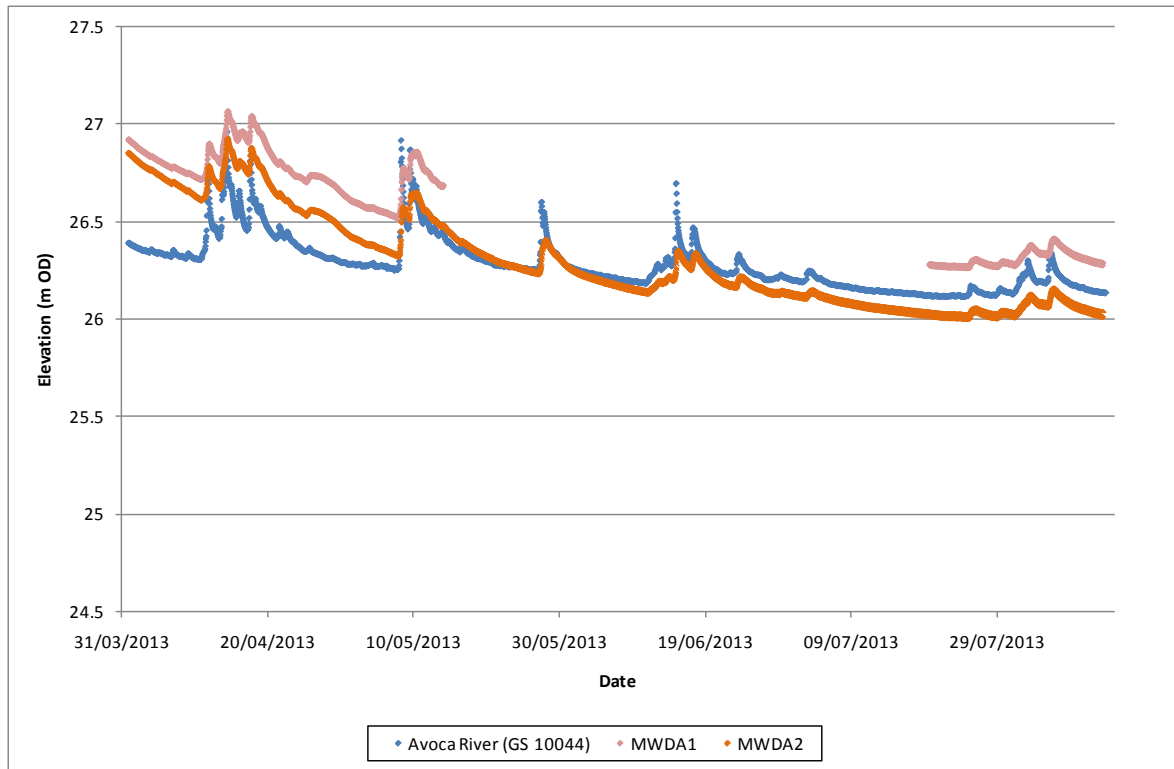
**Figure 11 Comparison of Groundwater Elevation and Elevation of the Avoca River (GS 10044) at the Deep Adit Area from 1 Apr to 12 August 2013**

On 8 and 9 May a significant hydrological (rainfall) event which resulted in groundwater levels rising in MWDA1 and MWDA2 by approximately 0.3 metres. There were occasions over this period where a negative gradient can be observed between the river and MWDA1, as shown in Figure 12. During 8 and 9 May period the river water level also rose but more rapidly which resulted in water moving into the monitoring well area, apparent from the rise in groundwater levels. It is likely the river water moved into an unsaturated zone, which could result in mobilising new metals if they were not exposed before.

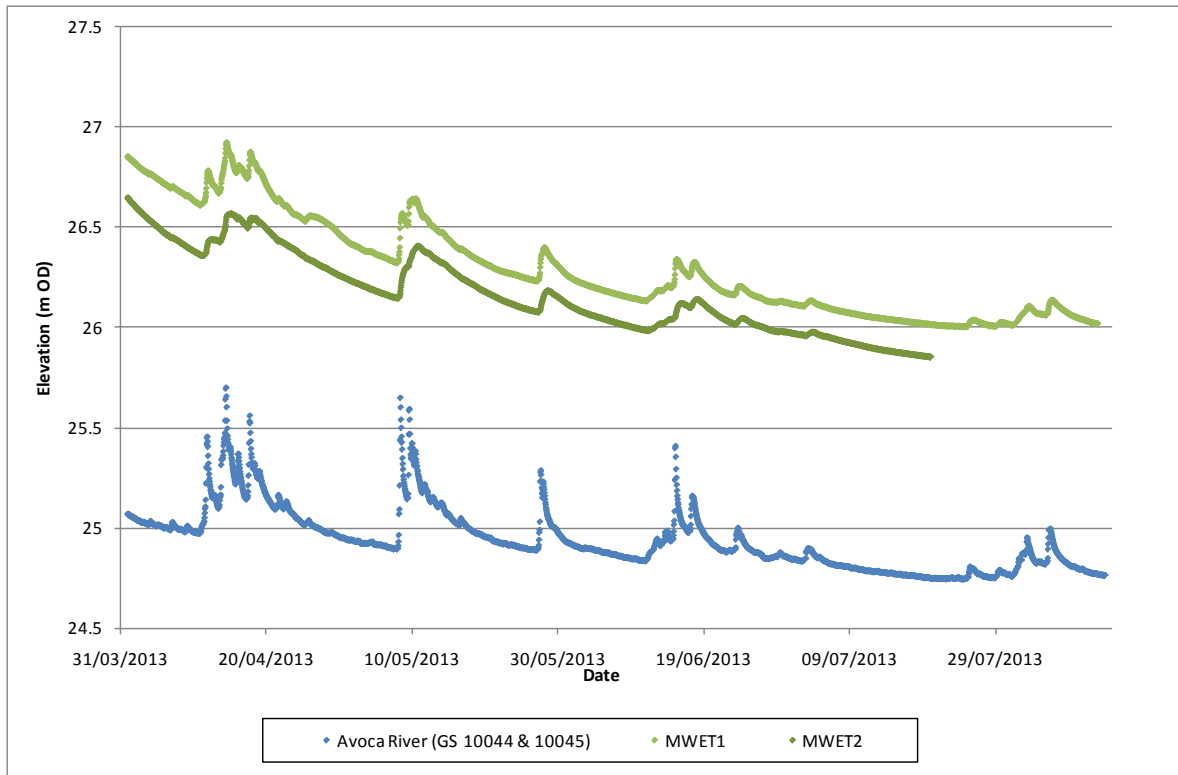
**Figure 13 Comparison of Groundwater Elevation and Elevation of the Avoca River (GS 10044 & 10045) at the Emergency Tailings Area from 1 Apr to 13 August 2013**

For MWET1 and MWET2 only positive gradients were observed with a minimum gradient of 0.017 (MWET2) and a maximum of 0.025 (MWET1) during the monitoring period. Note that the elevations are based on a GPS survey of the boreholes and the river water elevations was estimated using both the Whites Bridge GS elevation and the Wicklow Maintenance Yard County Council gauges because they are located equidistance between the gauges.
