The Department of Communications, Energy and Natural Resources

Feasibility Study for Management and Remediation of the Avoca Mining Site

Feasibility Study

December 2008

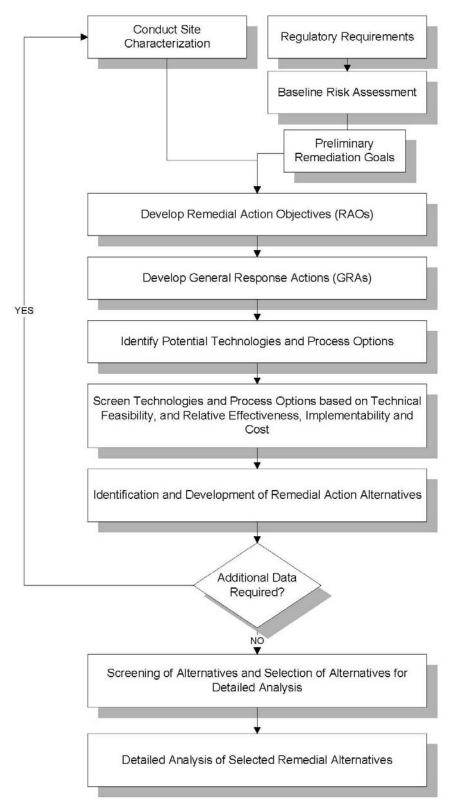
Figure 1-1 General Feasibility Study Approach

The feasibility study was conducted following the approach shown in Figure 1-1. During preliminary (Phase 1) evaluations conducted in May 2007, existing data and limited new data collected in April 2007 were used to prepare the following evaluations:

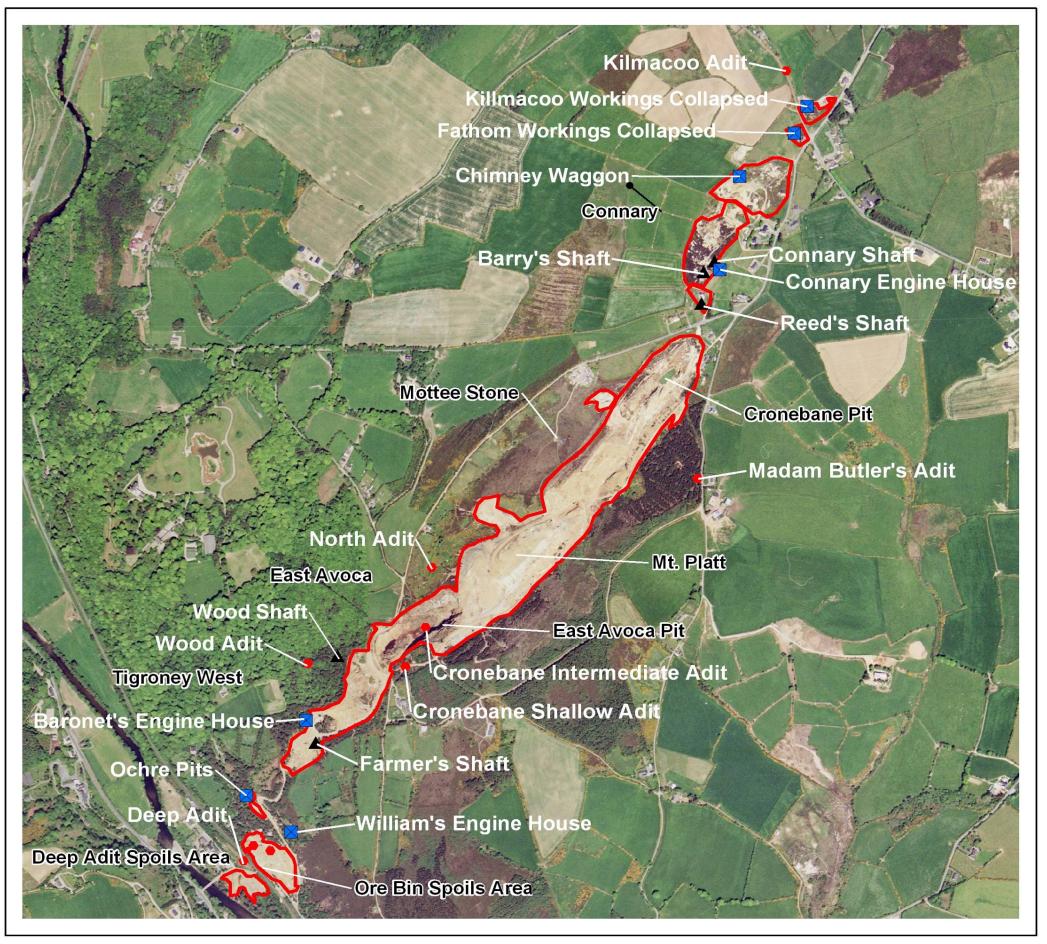
Figure 2-2 Site Features - East Avoca

- Spoils and Mining Areas
 - Adits
- ▲ Shafts
- Mine Features

Two shafts were found to be open; Air Shaft (at West Avoca) and Farmers (at East Avoca) (see Figures 2-2 and 2-3 for locations). Since initial inspection, Farmers Shaft has had a steel grate placed over it.

Many of the 19th Century engine houses and tramway remains have been conserved by recent works, although some appear to require further attention and all will require ongoing maintenance. Williams Engine House (see Figure 2-2) contains a number of dangerous sections. The risks imposed by this structure are high because there is easy access – the gate in the surrounding fence has been removed. The lower western window arch on the northern side has a missing keystone, leading to loose stones and potential instability of the wall. There are several unprotected drops. The worst is above what is believed to be the stoking hole to the boilers. This is partially covered by a thin rotting piece of plywood and constitutes a serious risk.

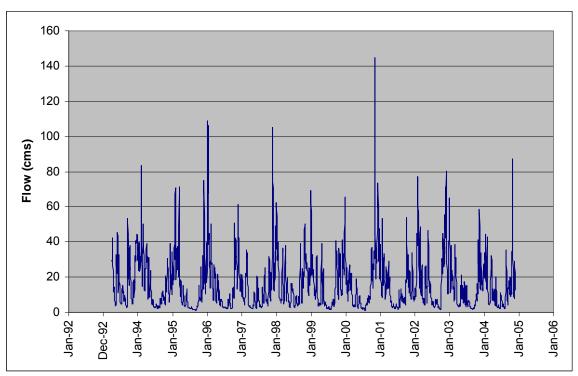
Figure 2-4 Net Estimated Flow of the Avoca River Near the Avoca Mines

While a permanent gauging station does not exist at the Avoca mine site, flows were estimated from rainfall-runoff modeling as part of the Eastern River Basin District project (CDM 2007). Calibrating initially to measured flows at Station 10002 on the Avonmore River and Station 10028 on the Aughrim River, the estimated flow in cubic metres per second (cms) just downstream of the Avoca mine site for the period 1993–2005 is depicted in Figure 2-4. The wide range of estimated flow conditions implies a rapid response to rainfall that in turn is a function of the physical characteristics of the Avoca catchment (high rainfall, steep topography, thin soil cover, low permeability bedrock). The estimated flow for the period on Figure 2-4 ranged from 1.12 to 144.5 cms with a mean of 15.6 cms. The estimated Q95 (flow exceeded 95 percent of the time) was 0.97 cms.

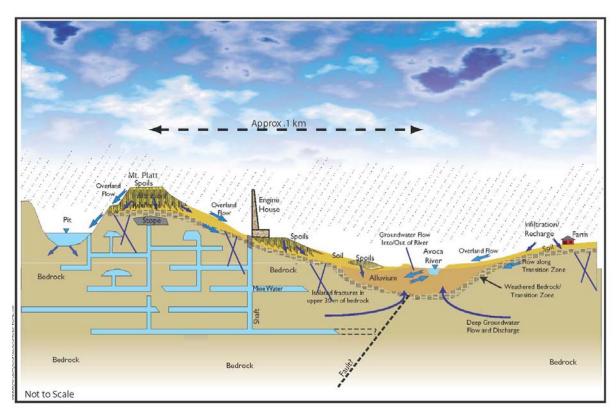
Figure 2-5 Schematic Cross-Section of Flow Components Influencing the Avoca River

"Interflow" is defined as the flow that takes place at the very top of bedrock, near or at the contact with the overlying subsoils. The interface between the top of bedrock and subsoil materials is chemically weathered and comprises a dense network of shallow fractures that is more interconnected than fractures at greater depth. As such, "interflow" represents a transition zone between subsoils and underlying bedrock. The transition zone may be only a few metres thick, and is regarded as being more permeable or transmissive than deeper bedrock. Interflow in the mine area is typically captured by the open pits or underground workings. Near the Avoca River, interflow will enter the alluvium and the Avoca River or emerge as seeps or springs.

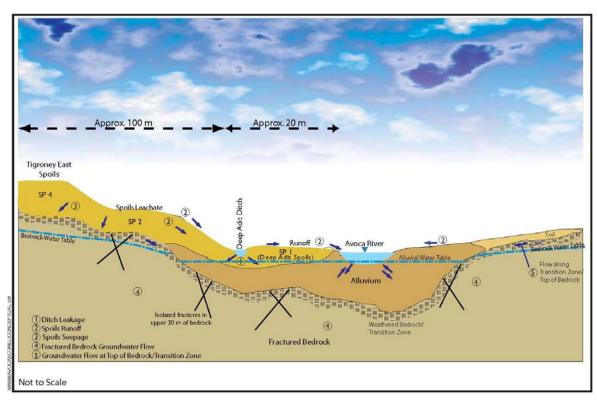
Figure 2-6 Schematic Cross-Section of the East Avoca Area Upgradient of the Deep Adit

"Deep" groundwater is considered to be groundwater flow in bedrock proper, beneath the transition zone with interflow. "Deep" groundwater flow at Avoca occurs in discrete fractures or fracture zones that represent zones of enhanced permeability. Varying degrees of rock deformation can be observed in the open pits on both sides of the Avoca River, and these deformations influence bedrock permeability. Bedrock is deformed by both folding and faulting; both of which are associated with fracturing and permeability development. Thus, "deep" groundwater flow is heterogeneous, following lines of structural geologic weakness. Deep groundwater will also be captured by underground mine workings in the mine area. Near the Avoca River, deep groundwater will also enter the alluvium.

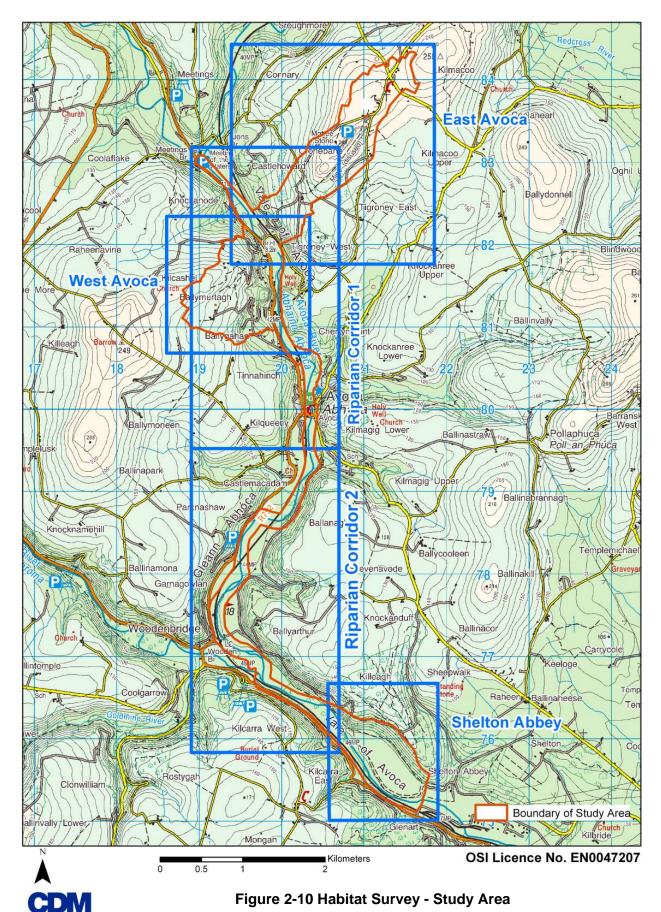
Figure 2-10 Habitat Survey - Study Area

Methodology - The habitat assessment was carried out on March 19 and 20 and April 9, 2008. It was conducted in accordance with The Heritage Council's Draft methodology, A Standard Methodology for Habitat Survey and Mapping in Ireland (Natura 2005) and habitats were classified according to The Heritage Council's A Guide to Habitats in Ireland (Fossitt 2000). The classification of habitats according to this Guide is primarily based on the combination of plant species that occur in a particular area. The Lidar survey (2007) was employed to aid delineation of habitat types for the mine sites and Shelton Abbey and aerial photography (2000) was used for the riparian corridor. Plant identification principally follows Webb et al. (1996). The results of the assessment are summarised in Table 2-16 and shown on maps for the East and West Avoca areas of Figures 2-11 and 2-12, respectively. The maps for the additional areas are contained in the Investigative Reports, Ecological Risk Assessment, CDM 2008.

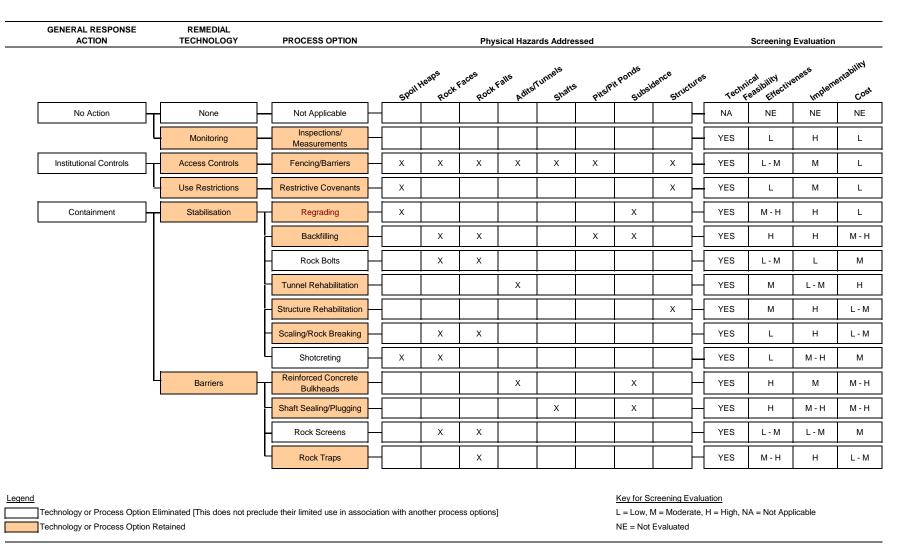
Figure 4-1 Screening of Technologies and Process Options - Physical Hazards (Page 1 of 2)

■ Rock Bolts – Rock bolts are considered to be low to moderately effective and have low implementability for the major highwalls at Avoca (Cronebane and East Avoca). The forces of nature (weathering, mass wasting) render rock bolting a temporary solution to highwall stabilisation. The rock faces are very difficult to access, without first backfilling the pits. There is increased risk to workers working close, and with impacting methods, to the rock faces. Rock bolting is moderate in relative cost. Due primarily to implementability concerns, rock bolting is not retained for use in development of remedial action alternatives.

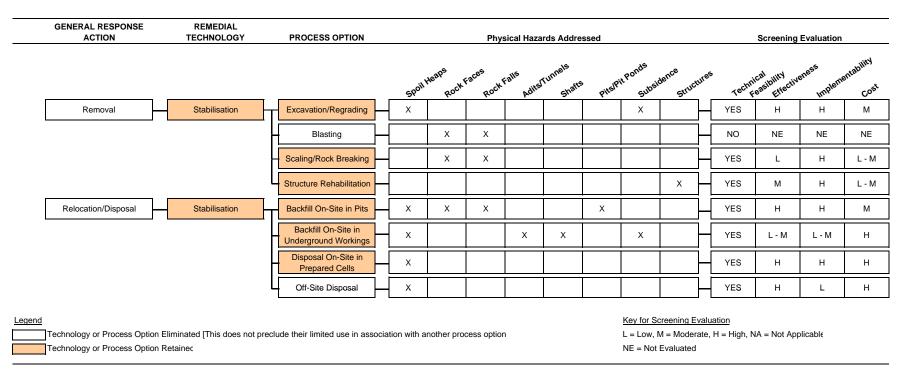
Figure 4-1 Screening of Technologies and Process Options - Physical Hazards (Page 2 of 2)

- Tunnel Rehabilitation Tunnel rehabilitation is a well established process for gaining re-entry to aged underground mine workings. However, there will be inevitable deterioration over time and, consequently, routine maintenance is necessary. It is a moderately effective method, depending on ground conditions. For Avoca, implementability is deemed to be low to moderate and cost to be relatively high. Tunnel rehabilitation is retained in order to facilitate bulkhead construction.

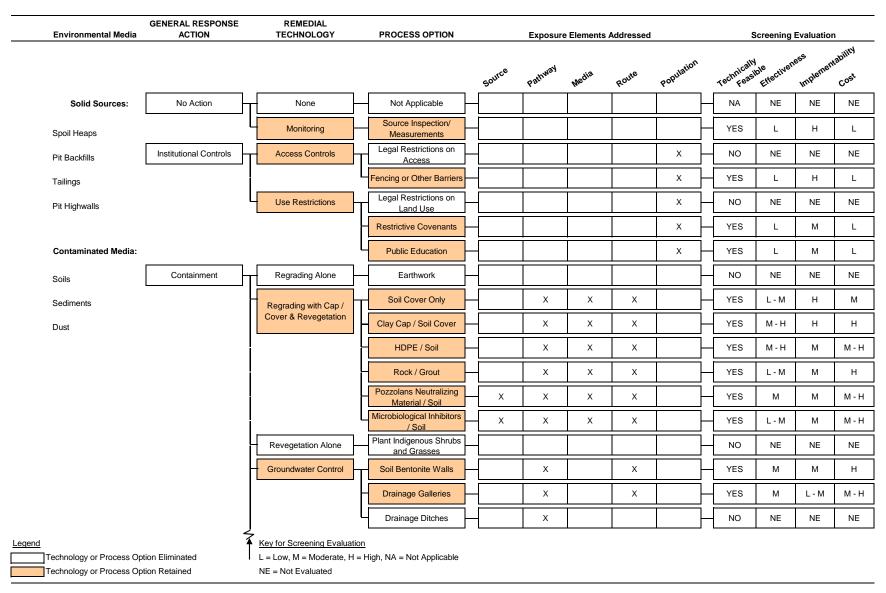
Figure 4-2 Screening of Technologies and Process Options - Solid Sources and Media (Page 1 of 3)

Revegetation of the surface of solid sources or contaminated media by itself does not treat contaminants or contaminated media of concern and is therefore not considered technically feasible. Therefore, revegetation alone is not retained. Even though the technology is not highly effective in its own right, it is an essential complement to a soil cover. Use of indigenous plant species results in landscape that is consistent with the current character of the Site. It is highly implementable and relatively low in cost. In combination with other process options, revegetation is retained for use in development of remedial action alternatives.

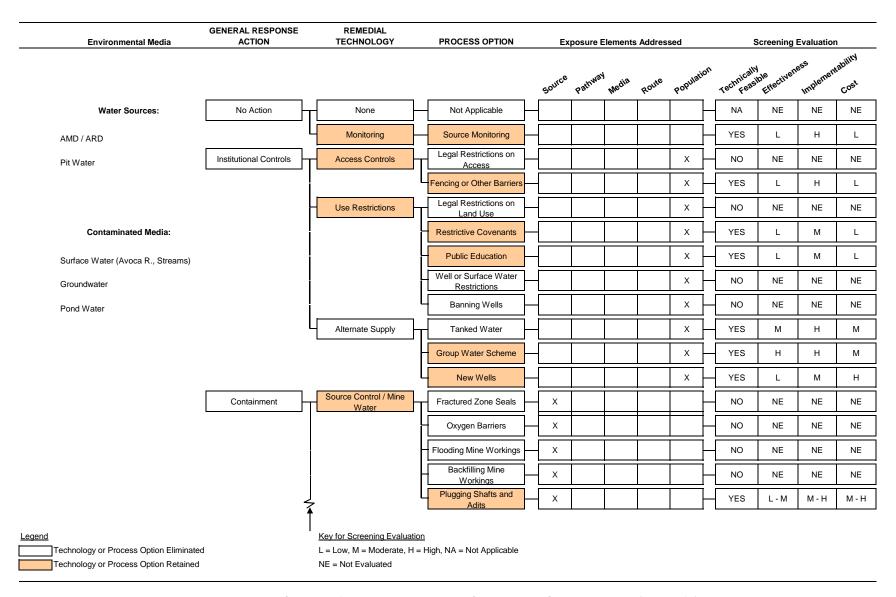
Figure 4-3 Screening of Technologies and Process Options - Water Sources and Media (Page 1 of 3)

Legal restrictions prohibiting site access, land use, or water use and banning drilling of groundwater wells are considered technically unfeasible and eliminated from consideration. However, restrictive covenants implemented through planning and permit processes are retained for further evaluation. The remaining identified institutional control technologies and options are considered technically feasible. The retained use restriction options range from low to medium in effectiveness, moderate to high in implementability and low in relative cost. The alternate water supply options range from low to high in effectiveness and moderate to high in implementability and relative cost. Institutional controls are retained for use in development of remedial action alternatives in conjunction with other process options.

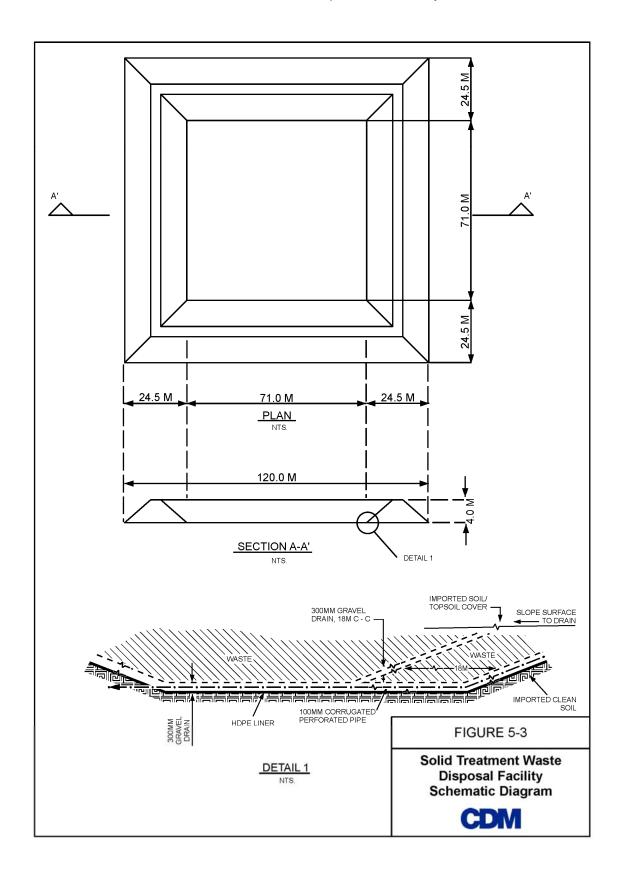
- There is a major change in the disposal process option for this remedial action, compared to Alternative No. 1 Water. Solid treatment waste from the active and passive treatment facilities will be disposed in a constructed onsite solid treatment waste disposal facility. The facility will be located in the reclaimed Cronebane/Mt. Platt area. It will be constructed as a permanent storage cell for the solid treatment wastes. The cell will be constructed on compacted fine grained soil, overlain by an HDPE liner. The liner will be overlain by a gravel and pipe underdrain system that will be covered by geotextile. Leachate or seepage from the overlying solid waste will be captured by the underdrain system and directed to treatment. The repository will be contained by earth embankments on all sides. A schematic diagram of the waste facility is provided in Figure 5-3.

The solid treatment waste from the active treatment plant will be a filter cake derived from the plant's filter press. It will be suitable for loading, hauling, and placing with conventional equipment. The treatment plant is estimated to generate 2 tonnes (about one truck load) of solid treatment waste per day. A private all-weather road between the treatment plant and the waste repository will provide ingress and egress that does not interfere with public traffic.
